*The Church of Hagia Sophia in Bizye (Vize): Results
of the Fieldwork Seasons 2003 and 2004*

Franz Alto Bauer and Holger A. Klein

History and State of Preservation

Preliminary Results of the 2003 and 2004 Fieldwork Seasons

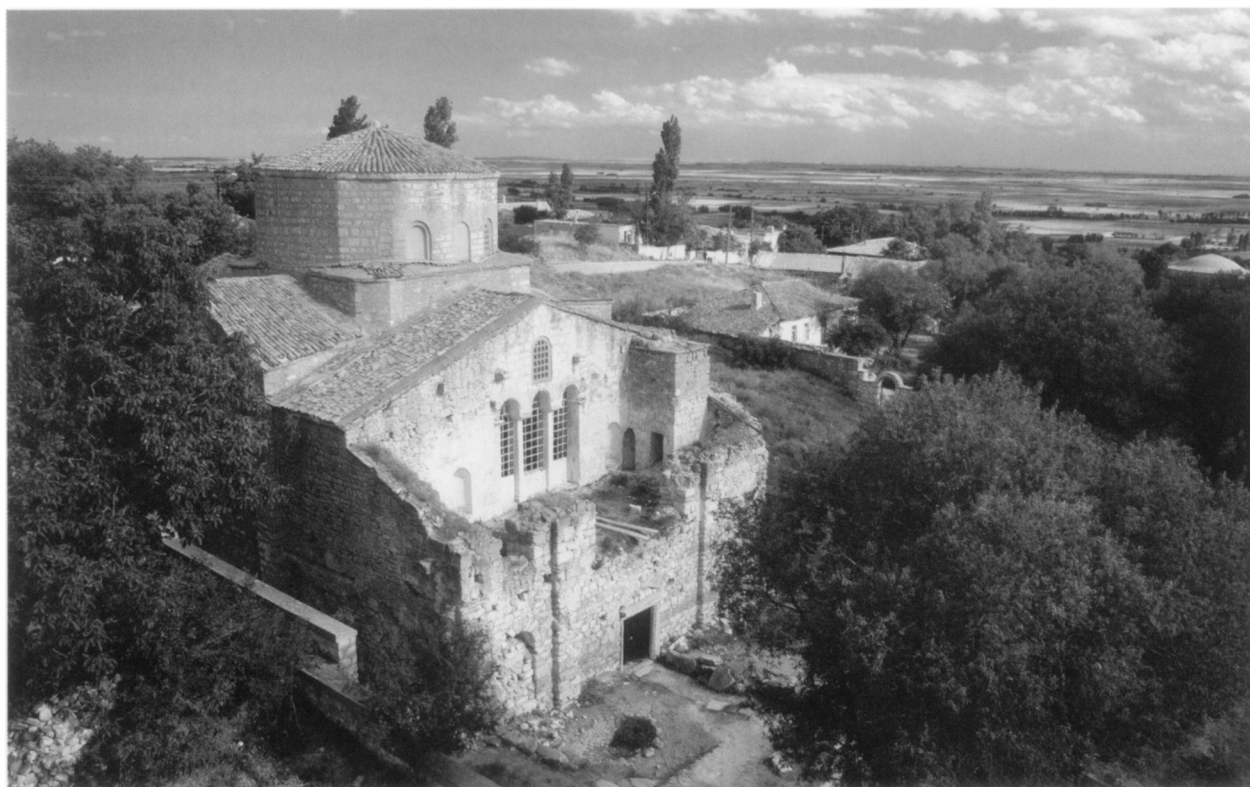
Fig. 1 Vize, Hagia Sophia, exterior from west, 2003 (this and all unattributed photos by the authors)

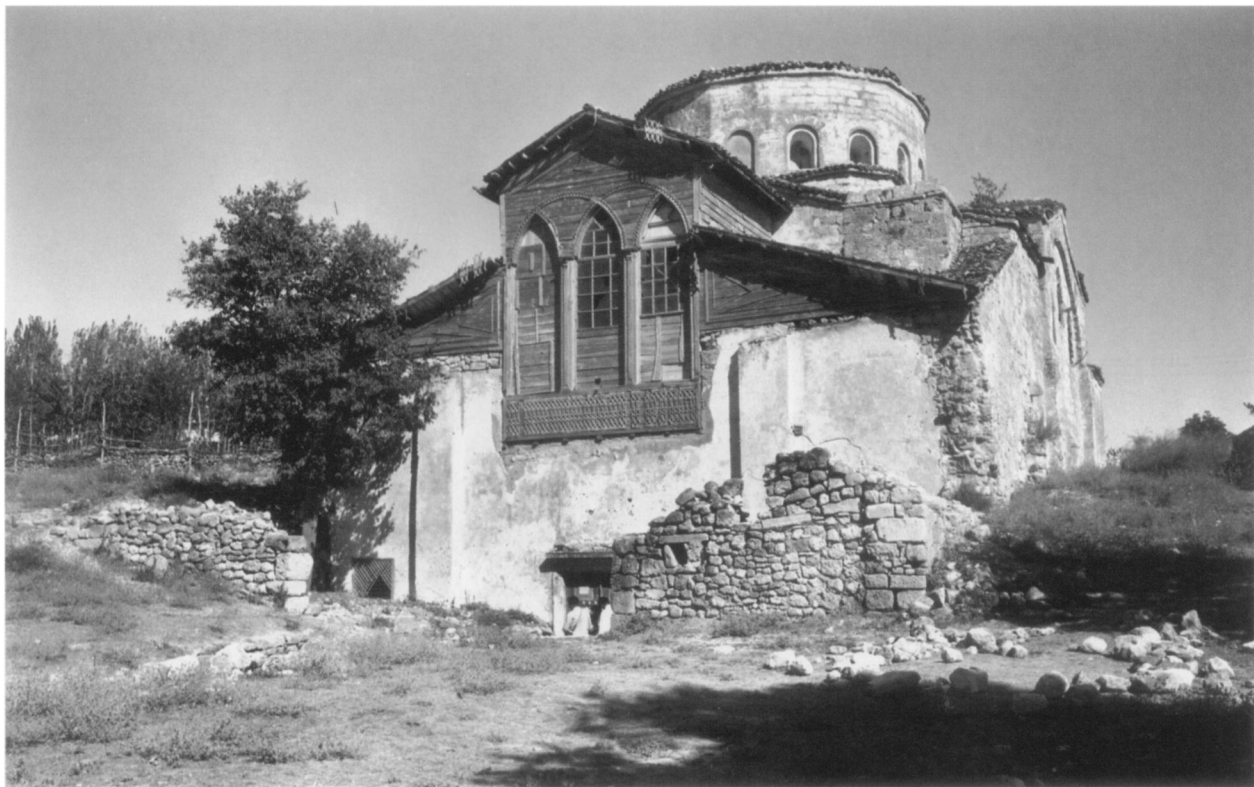
Fig. 2 Vize, Hagia Sophia, exterior from southwest, ca. 1960 (photo: C. Mango)

history of structural modifications and restorations in Ottoman times, the building seems to have served as the city's principal mosque well into the twentieth century. Its decline started only around 1912, when its minaret was destroyed by Bulgarian troops during the First Balkan War.²¹ In the decades that followed, the mosque seems to have slowly fallen into disrepair, since the Vakıflar Bölge Müdürlüğü considered its restoration already in 1952/53.²² The plan, however, was never carried out. About a decade later, the mosque ceased to function as a house of worship for the community of Vize (fig. 2).²³

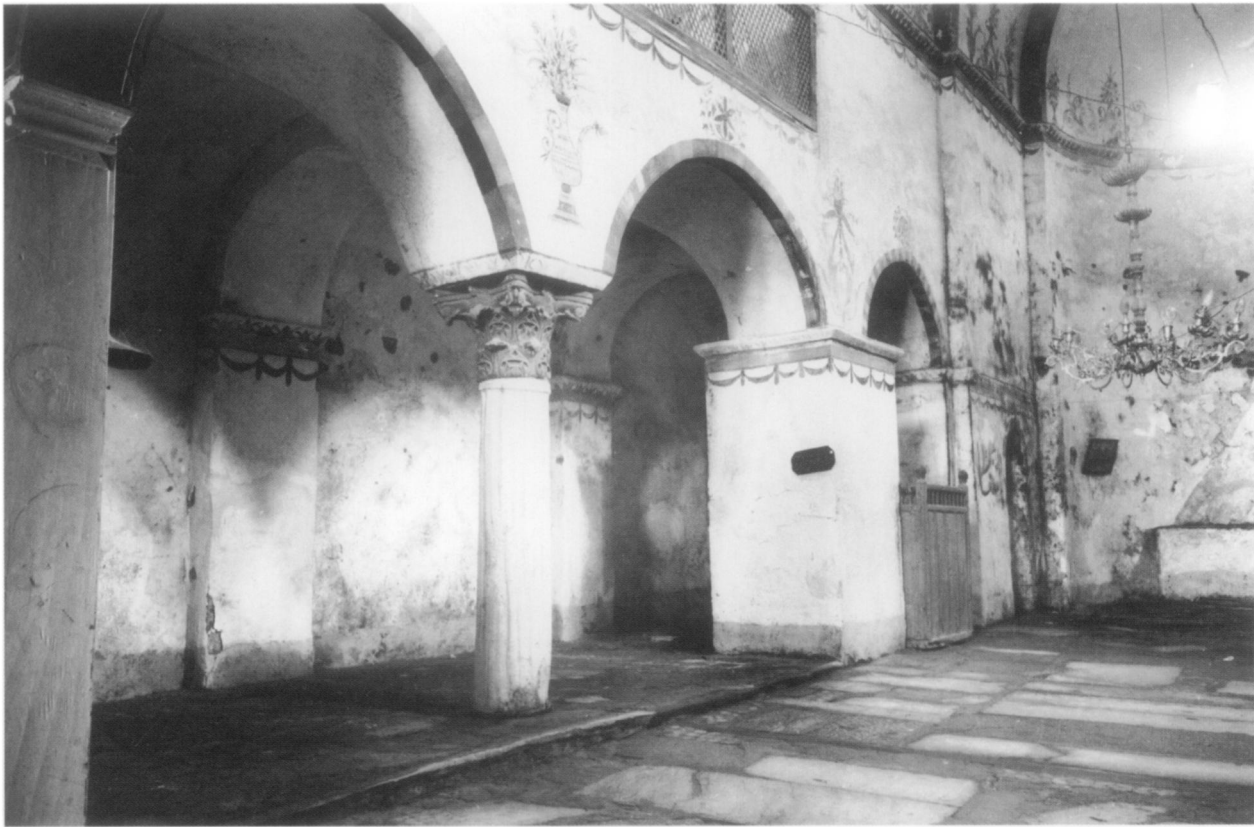
Fig. 6 Vize, Hagia Sophia, interior (photo: U. Peschlow)

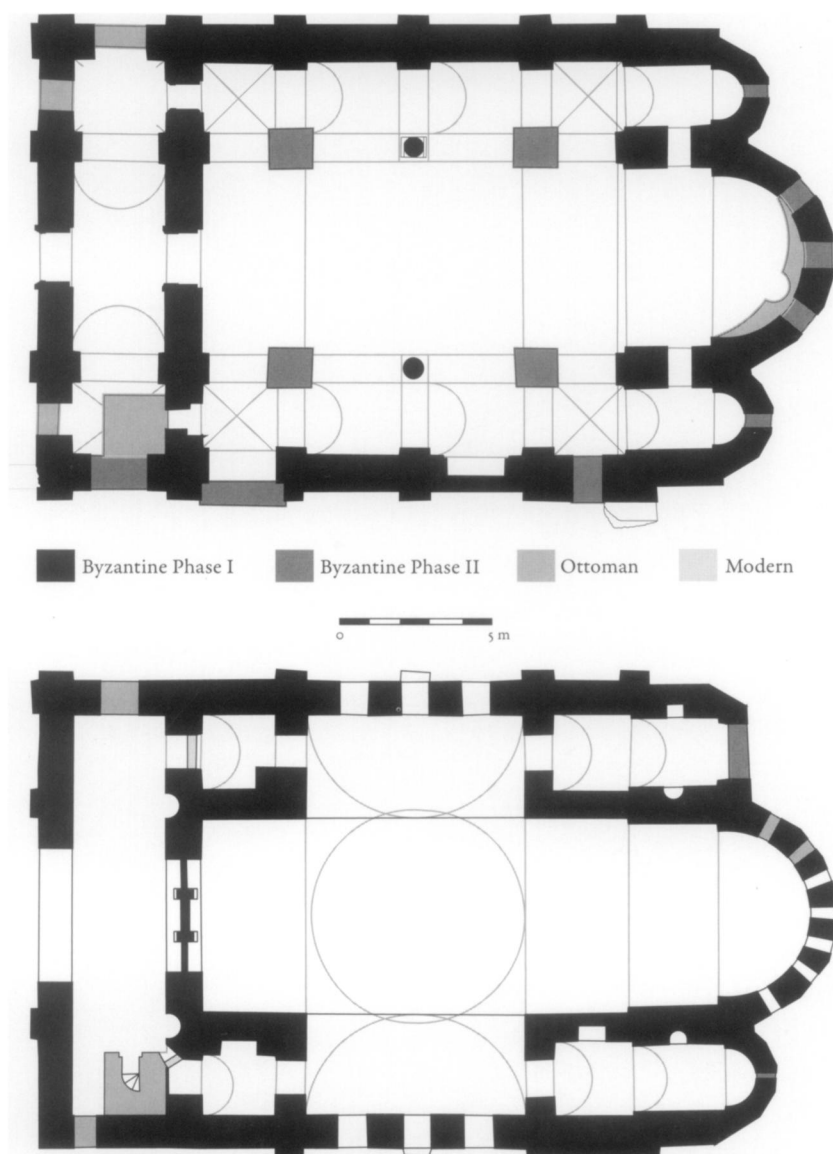
Fig. 7 Vize, Hagia Sophia, ground and gallery plan (drawings: R. Rosenbauer)

In addition to conducting a thorough photographic survey of the building, the primary goals of the 2003 fieldwork season were to establish a catalogue of surviving spolia on the site and to provide accurate plans and sections for the church. The latter was achieved by using the tape-measure system in combination with reflector and reflectorless tachymetry.⁴⁰ The ground and gallery plans that resulted from this survey (fig. 7) update and correct those published earlier by

⁴¹ Dirimtekin's groundplan, hardly more than a sketch, omits a number of important details, for instance the north and south entrances into the narthex, the base of the minaret, both arcossolia tombs in the south side aisle, and the small niche in the south wall of the diakonikon. Eyice's groundplan is more accurate, but he, too, omits an

important detail: the arcossolium in the westernmost bay of the south aisle. Eyice's gallery plan also omits a number of details: a square and a rounded niche in the eastern chapel of the north gallery and the irregular shape of the small chapel to the west.

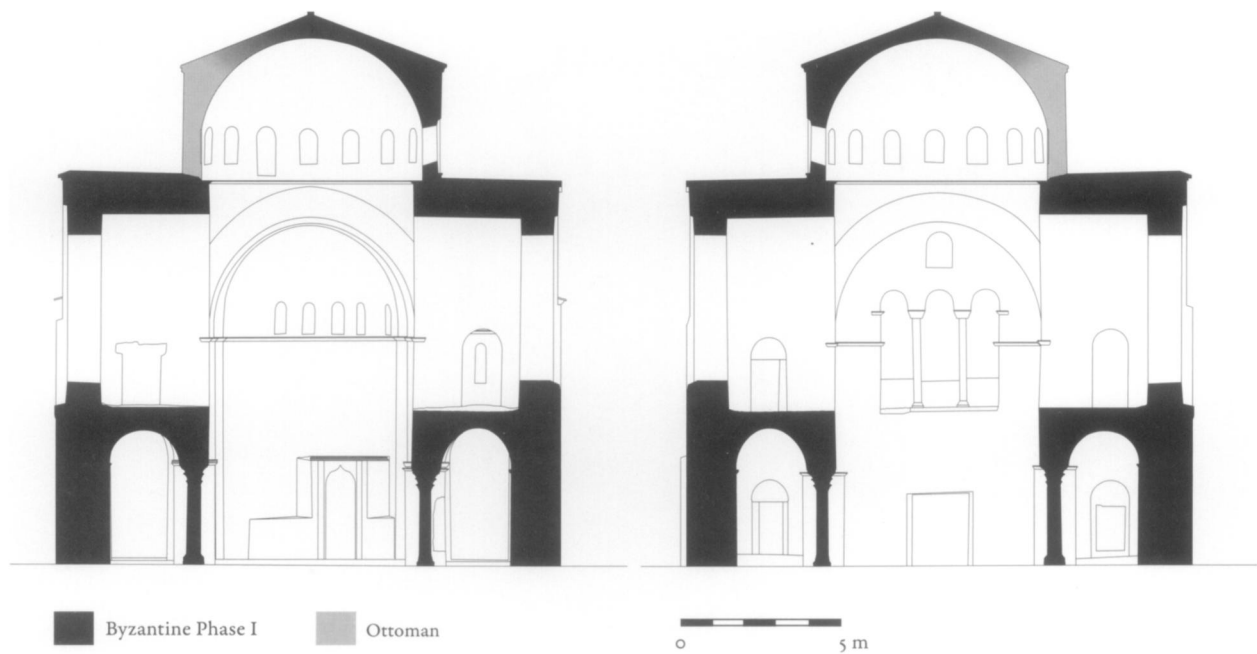
Dirimtekin and Eyice, both of whom surveyed the structure before the lower parts of the building's eastern end were exposed during the Vakıflar restoration.⁴¹ In addition, longitudinal and transverse sections (figs. 8–9) were provided to complete the archaeological record of the extant structure and to visualize the building's elevation and overall proportions. Where possible, the plans and sections indicate apparent changes in the building's structure and identify distinct phases of construction and restoration. The chronology of these phases should be considered preliminary and will need to be reassessed when the survey of the building has been completed. A few general observations on the building, however, are worth pointing out already. Abrupt changes in the stone- and brickwork of the central dome (fig. 10) as well as the blocking of eight of originally sixteen windows on the north side, for instance, seem to indicate a partial collapse and rebuilding of the sixteen-sided structure in Byzantine or Ottoman times. While it remains uncertain if the assumed collapse of the dome prompted the reinforcement of the four columns or piers that originally carried the weight of the dome on the ground level of the naos, the damage to the church—

Fig. 8 Vize, Hagia Sophia, transverse sections with views to east and west (drawings: R. Rosenbauer)

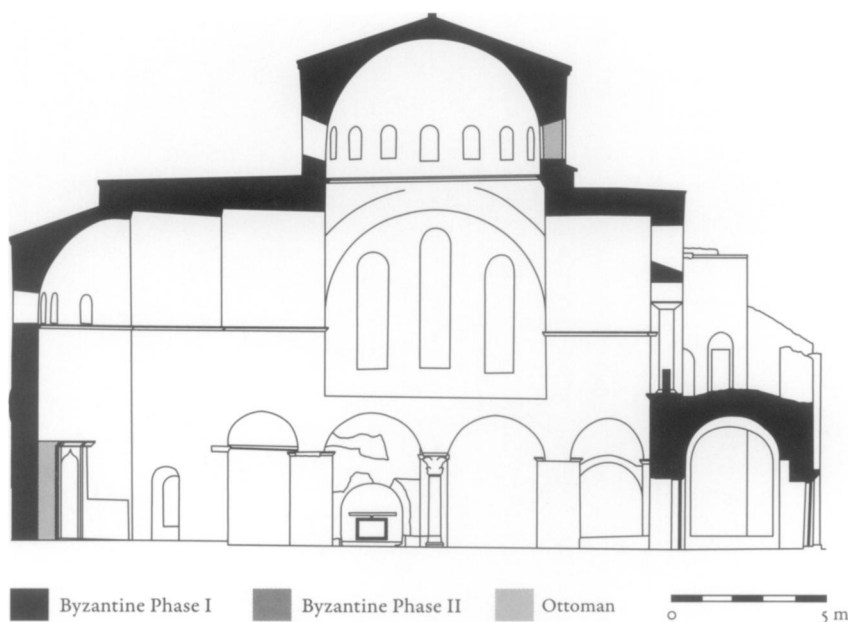
Fig. 9 Vize, Hagia Sophia, longitudinal section toward south (drawing: R. Rosenbauer)

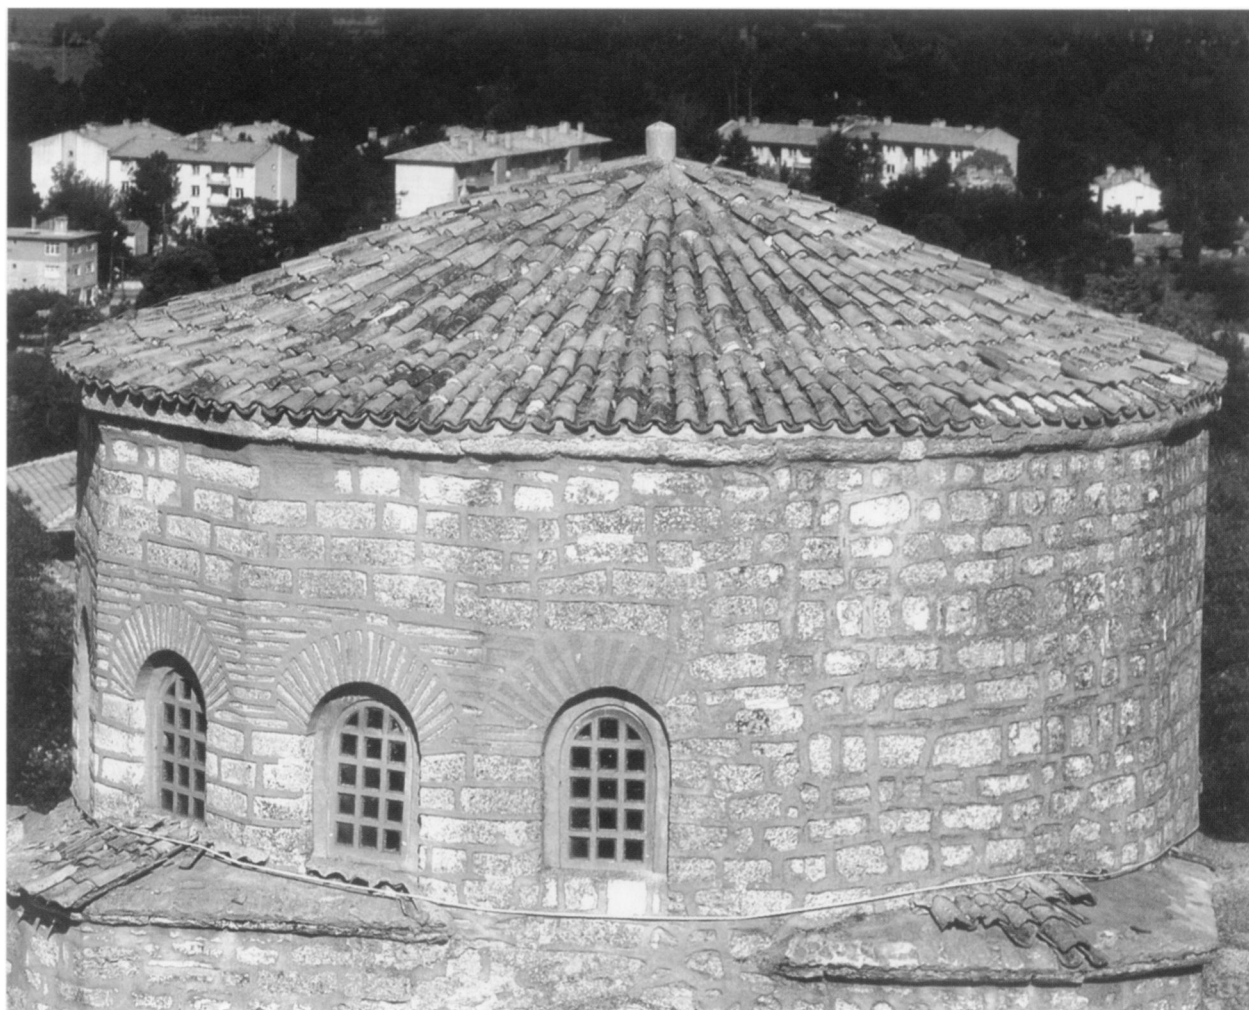
Fig. 10 Vize, Hagia Sophia, dome from east

presumably the result of an earthquake—seems to have been extensive.⁴² This at least is suggested by evidence for a complete rebuilding of the northeastern gallery chapel and the upper parts of the northern half of the central apse, which now lacks two of its originally seven windows.⁴³ On the lower level, the central apse once featured three large windows, which were subsequently blocked, most likely by an increased accumulation of earth at the eastern end of the church.⁴⁴ Small irregularities in the outer skin of the side apses further suggest that these, too, once featured windows on both the ground and gallery levels.⁴⁵ Other changes to the building's original fabric are clearly visible on the exterior of the south façade. At some point in the Byzantine period, an arcosolium tomb was added in the westernmost bay of the south side aisle. Unlike the arcosolium in the third bay of the south aisle, which forms an integral part of the wall and thus an integral part of the original building, the western arcosolium was clearly an afterthought that involved not only the partial opening of the south wall but also the addition of a reinforcement wall on the exterior (fig. 11).⁴⁶ A still-puzzling feature is the blocked archway and an adjacent wall fragment that protrudes southward at the eastern end of the south façade (fig. 12). It may be assumed that the archway once connected the diakonikon with an adjacent room or chapel to the south, but this claim cannot be verified at present.

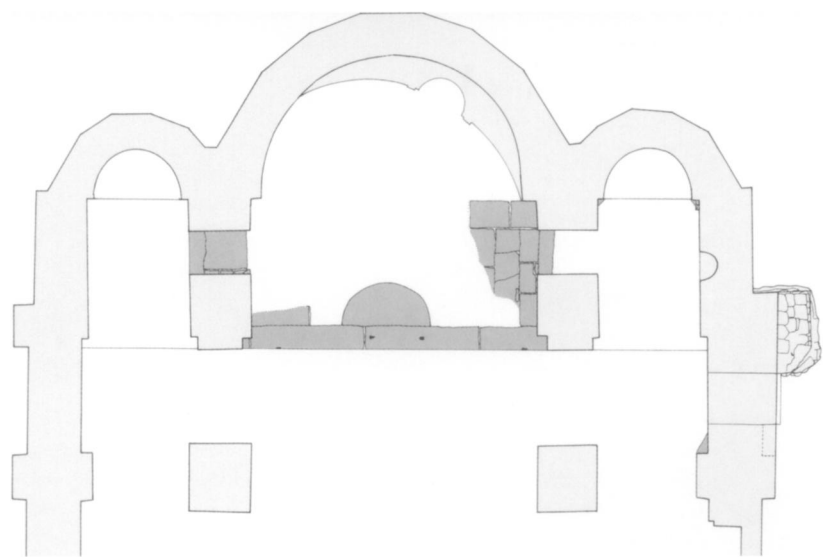
In the interior, the removal of the Ottoman marble floor during the Vakıflar restoration exposed fragments of the original Byzantine floor in the sanctuary and the corners of the side chapels (fig. 13). Furthermore, a row of greenish marble blocks was uncovered, which once defined the limits of the sanctuary (fig. 14). Traces of dowel holes

Fig. 14 Vize, Hagia Sophia, sanctuary with original floor tiles and tempon stylobate (drawing: R. Casagrande)

and markings on the marble blocks suggest that they once must have formed the stylobate of a templon screen. A central doorway about one meter wide can be reconstructed on the basis of dowel holes and traces of wear, which left the marble considerably more polished in the center than in other areas.

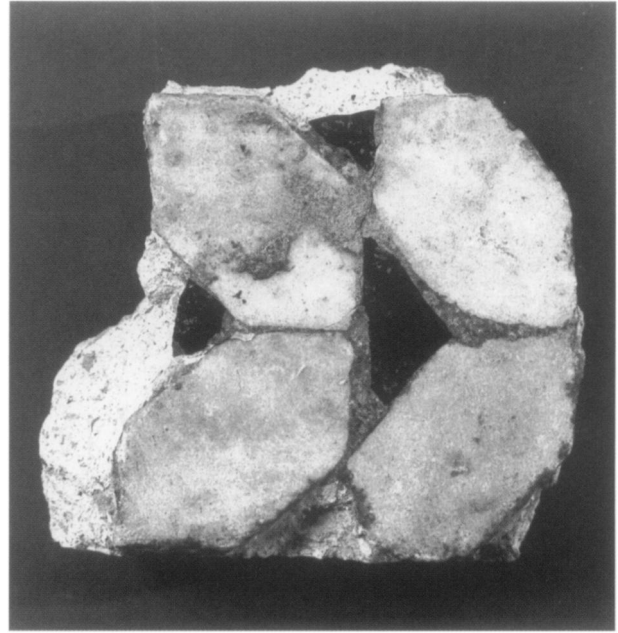
Fragments of the Byzantine opus sectile floor (fig. 15), previously described by Dirimtekin, Mango, and Eyice as having been reused in the Ottoman marble floor, were recovered during the 2003 field-work campaign together with other Byzantine spolia in the southwest corner of the narthex.⁴⁷ Among the more prominent pieces found in the narthex were parts of an ambo (figs. 16–17), fragments of a lintel with a central cross (fig. 18) that resembles closely those that can still be found in situ, and various fragments of a marble screen decorated with crosses in double relief (fig. 19).⁴⁸ A comprehensive catalogue of the site's spolia, which relate to the decoration of both the extant Byzantine church and its predecessor, is currently underway and will be published upon completion.⁴⁹

Fig. 15 Fragment of Byzantine opus sectile floor

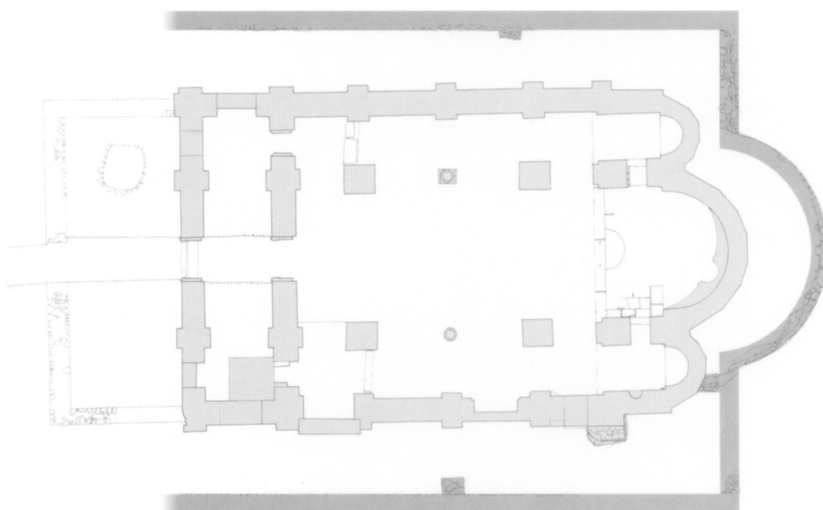
Fig. 23 Vize, Hagia Sophia, ground plan with remains of previous structure (drawing: R. Casagrande)

basilican structure that preceded the present church. The cleaning of the corridors and the main apse of this building allowed for the first time the drawing of an accurate plan of the remains of this structure (fig. 23), previously recorded in a sketchy drawing by Yıldız Ötüken and Robert Ousterhout.⁵¹

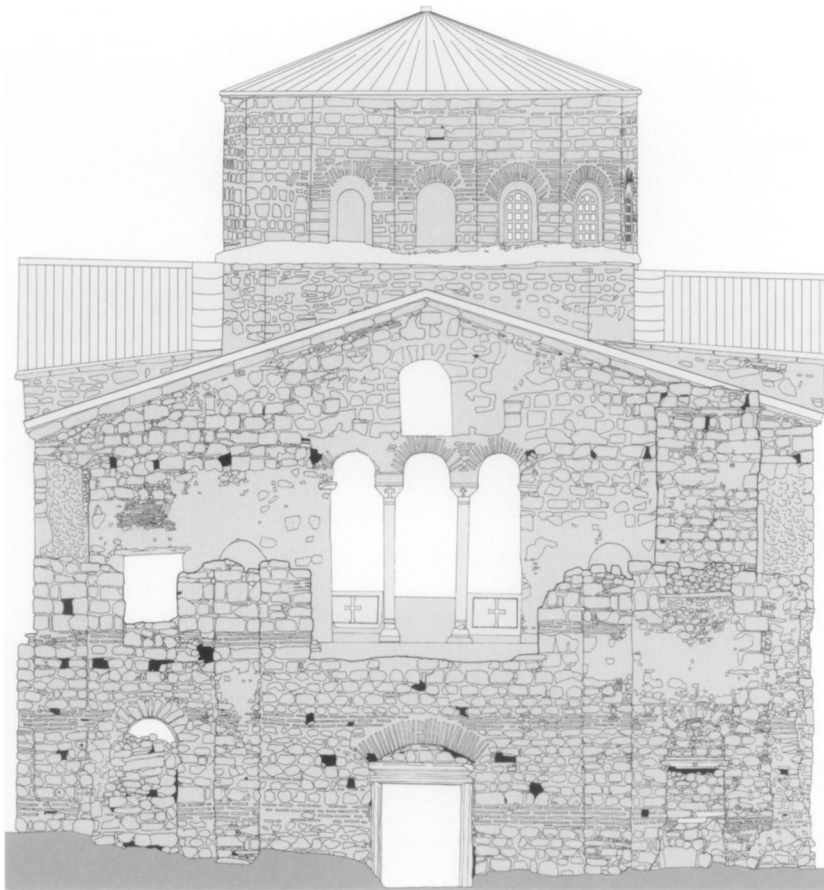
Fig. 24 Vize, Hagia Sophia, west façade (drawing: R. Rosenbauer and R. Casagrande)

the Edirne Vakıflar Bölge Müdürlüğü has meanwhile started its own restoration project on the building. In May 2006, a team of workmen was seen conducting restoration work on the building's west façade without supervision by an archaeologist or architect.⁵⁷ Given the devastating results of the first Vakıflar restoration campaign in the early 1980s, it can only be hoped that the current project will not once again result in the destruction of valuable archaeological evidence.

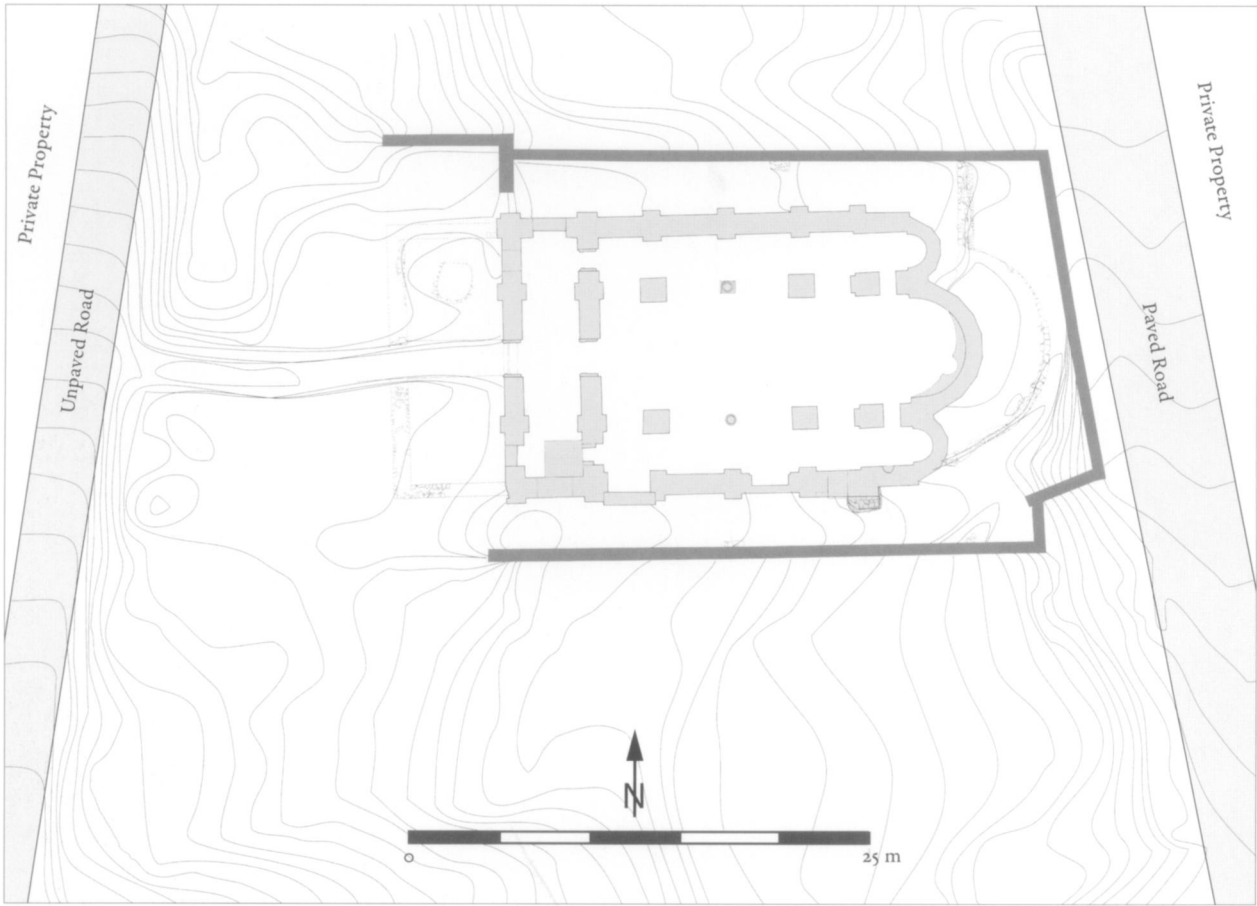
on which the church of Hagia Sophia and its predecessor were built (fig. 25).⁵⁶ An extension of the landscape model is planned for one of the next fieldwork seasons as it will not only help to determine the spatial relationship between the church of Hagia Sophia and a smaller church or chapel to its south, discovered during roadwork, but also facilitate a reconstruction of their exact location on the acropolis in relation to the surviving system of walls and fortifications of the Byzantine city.

Fig. 25 Vize, Hagia Sophia, site plan
(drawing: R. Rosenbauer)
